# BELZONA PROTECTION OF WATER INJECTION SPOOLS

ID: 248

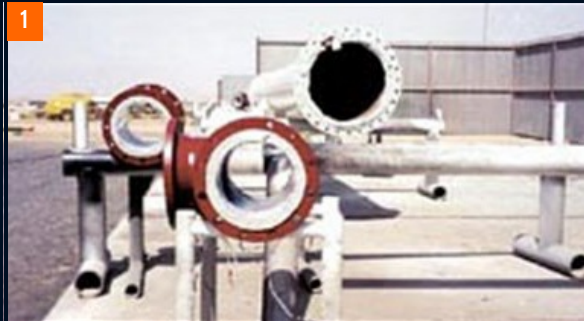
Severe erosion/corrosion on internal of pipe spools due to brackish water which contains sand and H<sub>2</sub>S.

1. Spools for coating
2. Application underway
3. Completed application
4. Completed application

The application was carried out in accordance with Belzona Know-How System Leaflet VPF-2.
