# BELZONA SEALS RE-DESIGNED WORKSHOP ROOF

ID: 2486

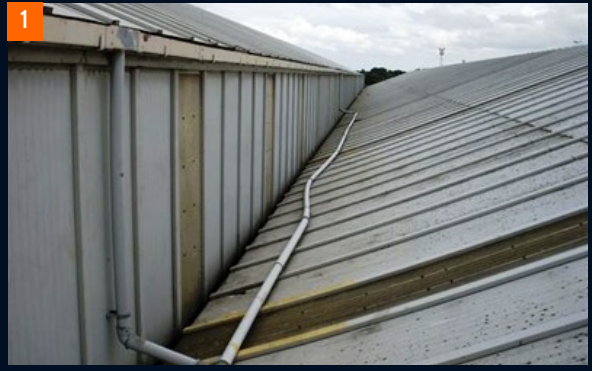
Heavy rainfall resulted in flooding within the workshop area. In addition, the drain pipes within the valley gutter were completely blocked.

1. Leaking Roof Area
2. Fabricated steel panels being installed
3. Belzona 3131 applied to the panels
4. Total encapsulation
