# BELZONA ANGLE IRON BONDED INTO PLACE

ID: 25

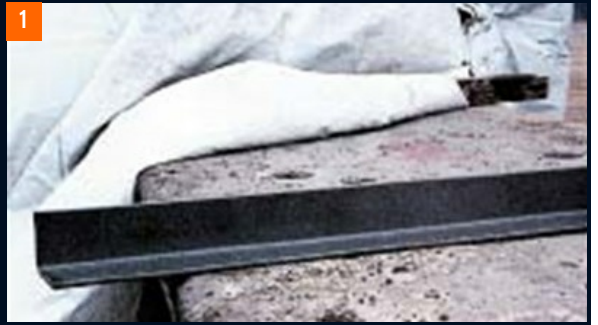
Concrete severely eroded. Exit end of concrete beam damaged by the impact of the scale bumping into the end of the scale sump wall.

1. Piece of 4 x 4 1/4 inch angle iron is prepared to be bonded into place.
2. Substrate conditioned with Belzona 4911 (Magma TX Conditioner).
3. Angle iron strongly bonded into place with Belzona 4111 (Magma-Quartz).
