# SMOOTH RUNNING WITH BELZONA

ID: 251

Clarifier tank used in treatment of wastewater.

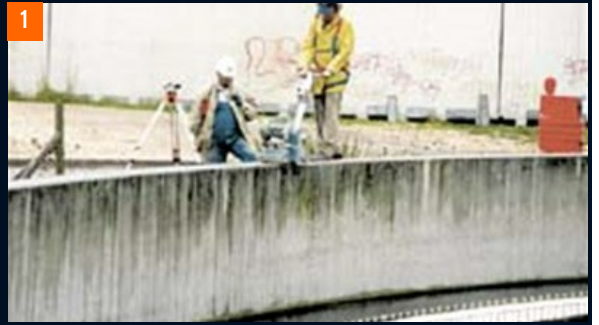
The running track was badly worn by constant abrasion from the distributor wheels.

1. Surface preparation underway
2. Metal formers being used to obtain accurate levels
3. Completed application with distributor running on track. Note rebuilt and sealed joint.

The application was carried out in accordance with Belzona Know-How System Leaflets TCC-11, TCC-12 and FPA-1.
