# A COST EFFECTIVE SOLUTION TO SEVERE PITTING - 11 YEARS LATER: PERFECT

ID: 252

Amine reboiler heat exchanger

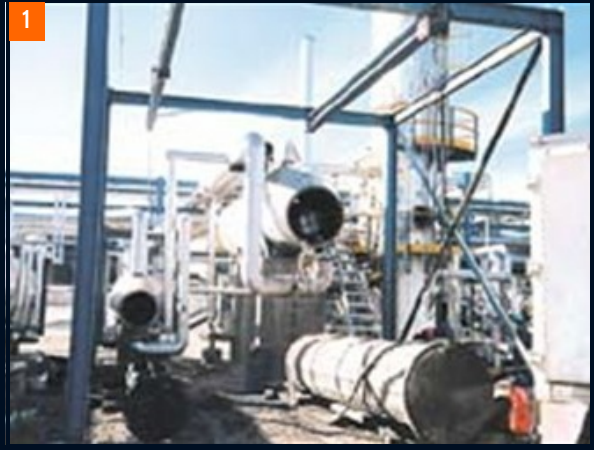
Severe pitting at froth line top and side walls.

1. Amine Reboiler
2. Grit blasted, surface checked for impurities and salts
3. Application of Belzona 1311 and Belzona 1321 completed
4. Inspected one year later. Scaling of chemicals used in the process, when scraped off, revealed Belzona application was still in excellent condition.

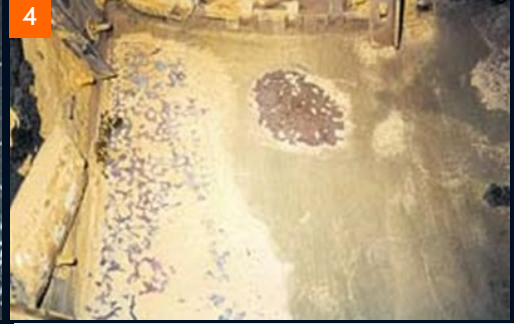
The Belzona System was more cost effective than the alternative of a metalizing spray weld repair. The repair has held up and the heat exchanger is still in operation, 11 years later.
