# BELZONA 1311 (CERAMIC R-METAL) SAVES A PLANT SIX WEEKS OF DOWNTIME

Flame plate heat exchanger

Oil and gas plant - Alberta, Canada

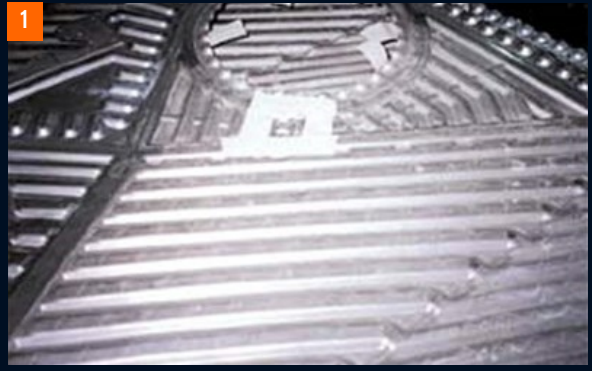
Small pin holes had developed in the heat exchanger plates

1. 1/16 inch pin holes masked off in prepared surface area
2. Belzona 1311 (Ceramic R-Metal) applied and force cured with heat lamps
3. All four flame heat exchanger plates are ready for installation

The application was carried out in accordance with Belzona Know-How System Leaflets HEX-5 and a modified version of TCC-5.
