# BELZONA BRIDGES THE GAP

ID: 255

## PROBLEM

Having to connect new, industrial polypropylene pipe to the old iron pipe which is severely pitted, making it impossible to obtain a water tight seal for the joint sealing ring.

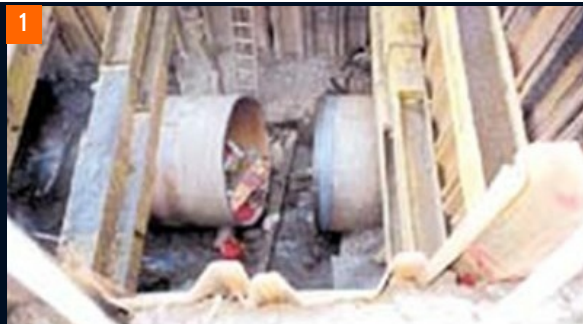
1. Overhead view of both old and new pipe before repair and connection
2. The sections of pipes that were to be connected
3. Run the pipes with connecting collars, following Belzona repair
4. Completed repair

Due to restricted and muddy working conditions it was not possible to allow machinery to be used for this repair, therefore a hand-held angle grinder was used to prepare the surface. The Belzona® 1111 (Super Metal) made a smooth collar around the pipe thus providing a watertight seal.
