# PRESS ROLL REPAIR WITH BELZONA

ID: 2557

Size press roll from a paper machine.

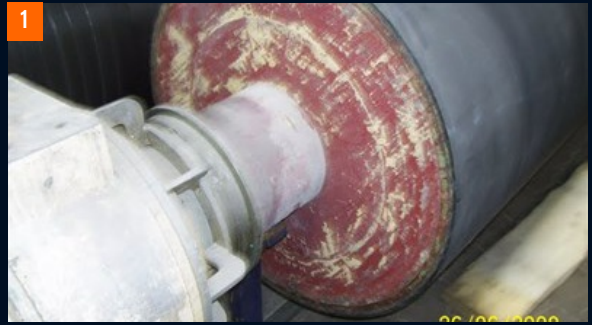
Corrosion had led to perforation of side plates.

1. Corroded side plate
2. Grist-blasted side plate
3. Application of Belzona 1111
4. Completed application
