# BELZONA RESTORES ACID FLOW BY REFURBISHING CONCRETE CHANNEL

ID: 256

A channel used to contain and transport sulfuric acid.

Coal-fired power station - Scotland

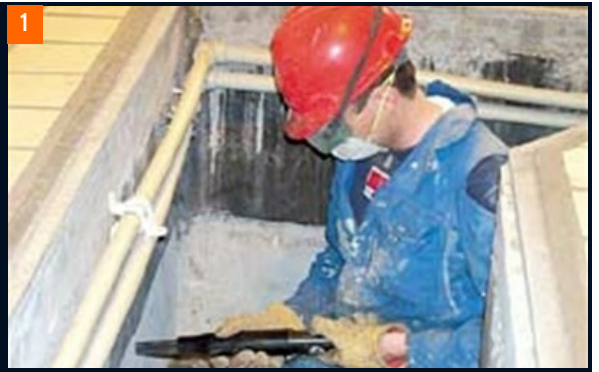
1. The surface is being prepared
2. The failed screed can be seen prior to its removal
3. Belzona 4181 being applied
4. The channel back in service

The application was carried out in accordance with Belzona Know-How System Leaflet TCC-15.

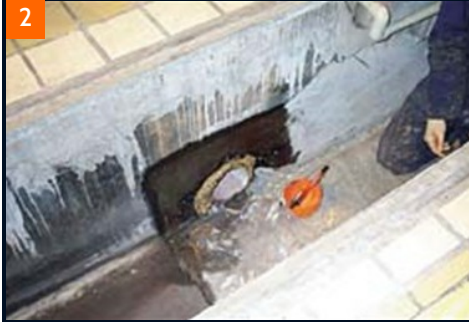
The concrete channel was deteriorated from the acid. A previously applied bituminous screed was failing which caused peaks and troughs in the channel.
