# BELZONA HELPS KEEP THIS POWER PLANT ON-LINE

A bearing seizure damaged the armature shaft in fuel generator.

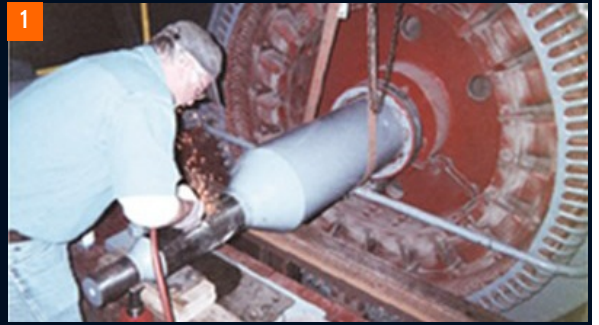
Damaged armature shaft.

1. Surface preparation
2. The former is being tightened
3. The former is removed

The application was carried out in accordance with Belzona Know-How System Leaflet MPT-2.

Belzona 1111 (Super Metal)
