# BELZONA REPAIRS A CLASSIFIER AND SAVES THE CUSTOMER THOUSANDS IN REPLACEMENT COSTS

Solids classifier in the grit removal system.

Water Treatment Plant - New Mexico  
U.S.A.

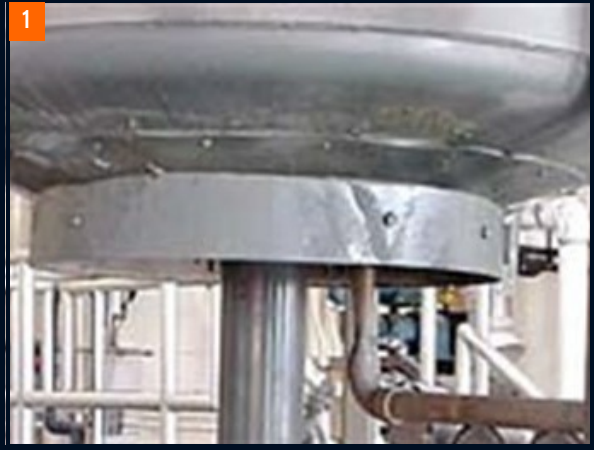
1. An overview of the equipment
2. A close-up of the damage
3. The surface is being prepared
4. The completed repair

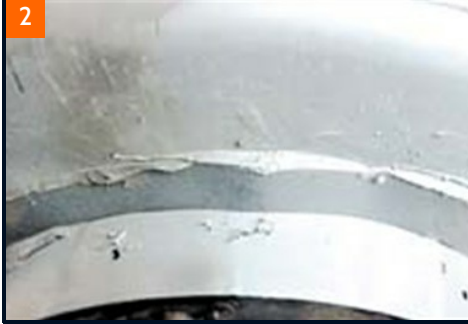
The rubber donut type ring was designed too small allowing the adjacent steel to wear through.

Belzona® 1111 (Super Metal) was used to bond several steel patches where the steel had worn through. Then Belzona® 2111 (D&A Hi-Build Elastomer) was used to re-create a durable donut replacement. Alternatives included replacement of equipment at \$14,000 each. Welding would have ruined the existing rubber donuts. The Belzona Solution was only \$600 for each classifier.
