# BELZONA RESTORES ARCHIMEDES SCREW

ID: 259

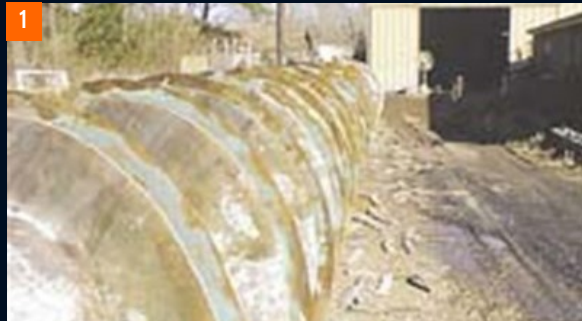
Corrosion/erosion caused the screw blades to wear down. The diameter of the angle was reduced so much that it could not lift the water.

1. Damaged Archimedes screw
2. A close look of welded outskirts coated with Belzona 1321
3. Entire screw edges were coated with Belzona
4. Completed application with cosmetic coating applied

The screw blade edges were worn down and the protective fiberglass liner had delaminated. After welding blade extensions all the way around, Belzona® 1321 was used to reinforce existing fiberglass liner, protecting the entire new weld.
