# LIFT STATION WET WELL STAYS IN SERVICE WITH HELP FROM BELZONA

ID: 261

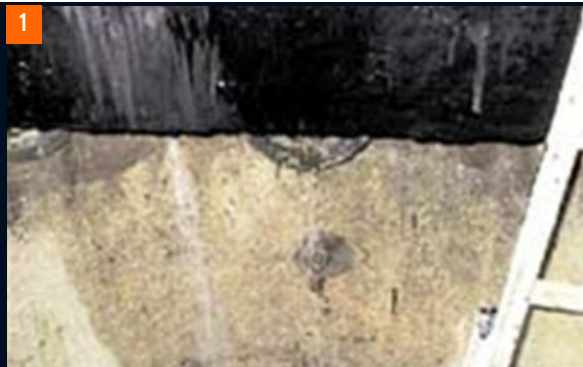
Hydrogen sulfide attack deteriorated the concrete in the wet well area of a lift station.

1. Deteriorated concrete surface with water penetration from outside
2. First coat of Belzona 5811 has been applied to the concrete surface
3. Second coat on the upper section of the wet well
4. Completed job

Severely damaged concrete surfaces above the sewer level were rebuilt with Belzona® 4141 and the entire internal surface of the lift station wet well was protected by two coats of Belzona® 5811. The Belzona Solution offered minimal downtime and long term protection against hydrogen sulfide attack.
