# BELZONA KEEPS THE TRAFFIC MOVING: FOUR YEARS AND GOING STRONG

ID: 262

Valve well cover ring seat, located on a busy road.

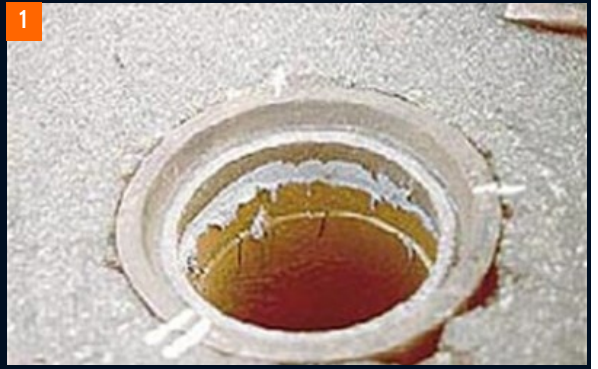
Continuous impact from traffic damaged the outer concrete ring seat causing problems. The traffic could not be disrupted for an extended period of time.

1. Close look at the damage prior to Belzona repair
2. Completed job, still in service after four years

The Belzona solution allowed the city to reset the valve well and manhole covers before further damage occurred, with the least amount of material and traffic disruption.
