# BELZONA 5811 REPEAT TANK APPLICATION

ID: 264

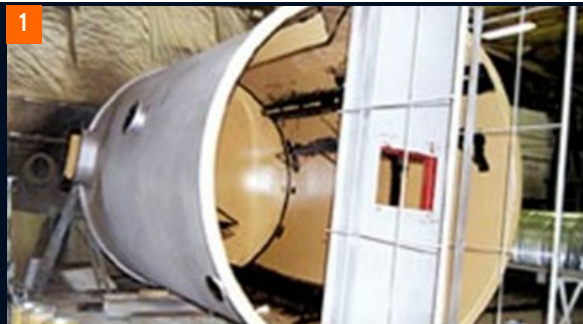
1. The first coat of Belzona 5811 (beige) applied and details being stripe coated
2. Second coat of Belzona 5811 (black) applied
3. Tank re-installed in original position

The application was carried out in accordance with Belzona Know-How System Leaflet TCC-5. After stripe coating welds, brackets and other awkward areas. The Belzona® 5811 was applied by heated airless spray.
