# SUCTION ROLL REFURBISHED WITH BELZONA

ID: 265

Internal surface of suction roll from paper machine

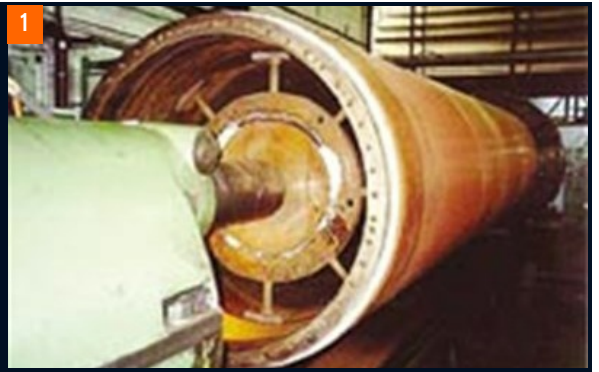
Suction box became loose and scored the suction roll surface.

1. The roll mounted in lathe
2. Belzona 1111 applied and some of the re-drilled holes
3. Final work being done on the rebuilt surface
4. The completed application.

The application was carried out in accordance with Belzona Know-How System Leaflet PDP-3. Worn area rebuilt with Belzona® 1111, machined to correct diameter, then holes re-drilled through suction roll.
