# BELZONA EMERGENCY RECLAMATION OF REFINER

ID: 266

Disc refiner

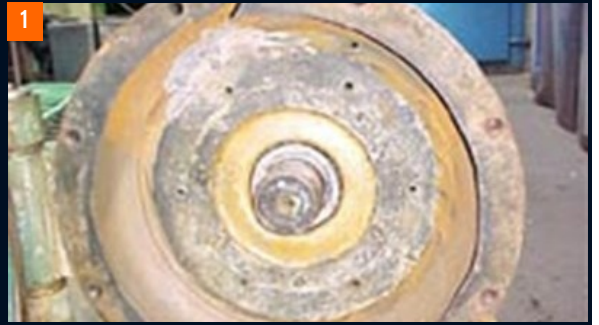
Severe erosion in the refiner body and the end cover/door led to several holes in the casing necessitating repair.

1. The refiner casing prior to preparation
2. After grit blasting, the damage and several holes were clearly evident
3. The repaired casing
4. The end cover/door was also fully refurbished
