# BELZONA REPAIRS LARGE VACUUM PUMP ROTOR

Nash vacuum pump rotor.

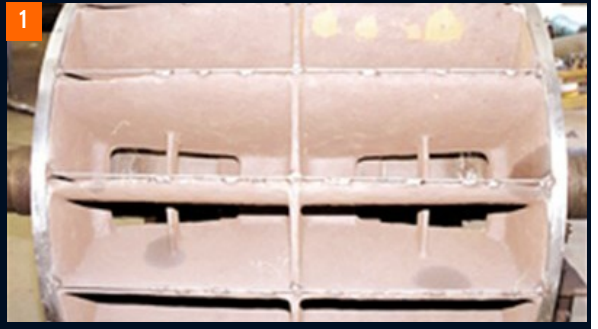
Contamination of the water seal with chemicals and pulp accelerating the erosion - corrosion of the rotor leading to a loss in pump efficiency.

1. The degraded rotor with metal framework welded on
2. The rotor rebuilt to original dimensions with Belzona 1111
3. The final touches being put to the Belzona 1341 coating
