# BELZONA RESTORES FELT RETURN ROLL

ID: 268

Felt return roll.

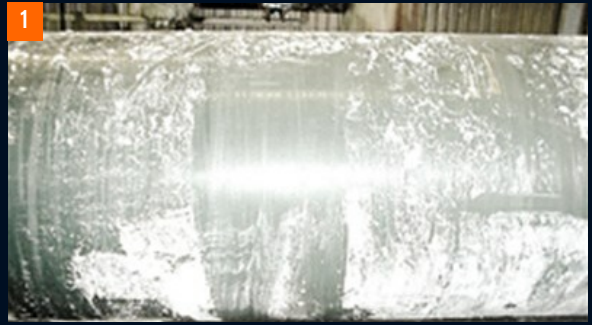
The fiberglass roll coating had worn to such an extent that the fibrous reinforcement was protruding from the surface of the coating, allowing water to ingress into the coating.

1. Previous coating showing signs of wear
2. Applying Belzona 1321
3. The roll in service on the paper machine
