# BELZONA PROTECTS AMINE REBOILER

ID: 2686

Amine reboiler vessel

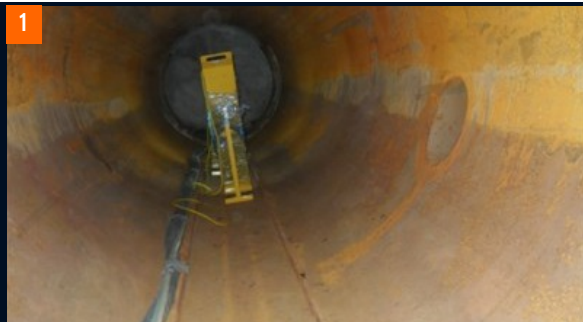
Internal corrosion with heavy pitting in areas.

1. Interior of vessel before blasting
2. Large areas of pitting
3. Vessel before application of first coat Belzona 1591
4. Coated vessel before final remedial work carried out

Application was carried out in accordance with Belzona Know-How System Leaflet TCC-5. Belzona® 1511 was used to fill in pitting. Belzona 1591 applied for overall corrosion protection.
