# BELZONA SUPERWRAP IN A REFINERY

ID: 2689

Hydrocarbon feed-line into the refinery.

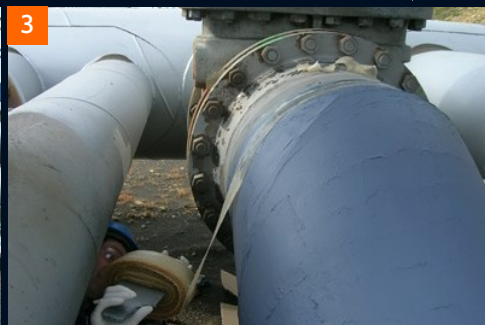
1. General view of the Refinery
2. Preparation
3. Application in progress
4. Completed repair

Belzona® SuperWrap system installed in compliance with the requirements of ISO/TS 24817 and ASME PCC-2.
