# BELZONA REPAIRS KAPLAN TURBINE BLADES IN FRANCE

ID: 269

Kaplan turbine hydroelectric power station on the Moselle River in France.

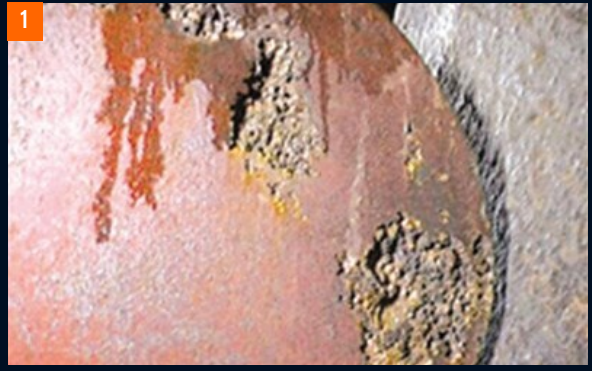
Erosion-corrosion of the blades leading to large loss in efficiency. In particular, cavitation had caused deep erosion in localized areas.

1. Cavitation-erosion damage present on the turbine blades
2. The blade edges were particularly badly eroded
3. Blade profiles being restored with Belzona 1111, using plastic strips to obtain edge detail
4. Completed application. Note the smooth surface obtained with Belzona 1341
