# THAT'S ONE BIG ROOF APPLICATION WITH BELZONA

ID: 2690

Waterproofing of the Olympic Complex roof.

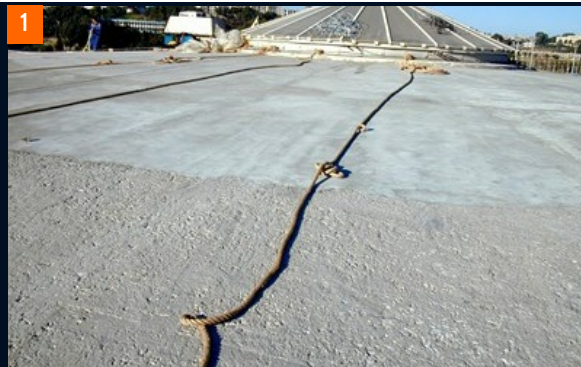
Corrosion and weather damage had caused the 12,000m<sup>2</sup> roof of the Olympic Complex to leak.

Damaged concrete roof Application of Belzona 3111 Completed application in 2003 Revisited application in 2014

Application was carried out in accordance with Belzona Know-How System Leaflet RPA-1. Firstly the asbestos coating inside the dome was removed. The roof was resurfaced using a cement based screed to provide a good base for the new coating. A fully reinforced Belzona® 3111 system was then applied.

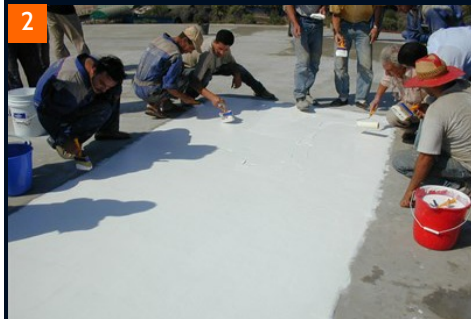
The Application was revisited in 2009. After 6 years in service, there was no deterioration of the roof structure. The coating, although covered in dust following a dust storm, was still in an excellent condition underneath. The coating still provided UV-resistance and was watertight.
