# LIVE LEAK SEALING WITH BELZONA

ID: 2691

Leaking cooling water pipe.

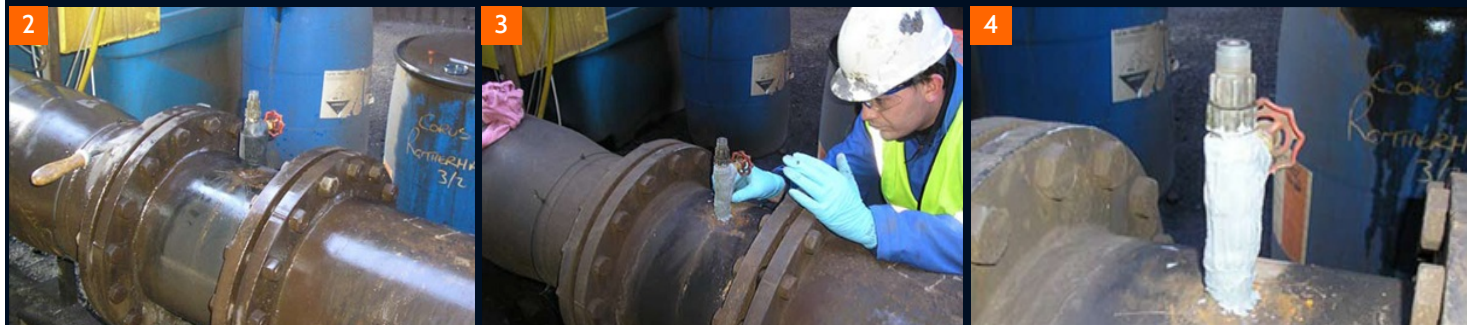
## PHOTOS

The pipe which carried the cool water to the primary mill was leaking. The engineers were looking to repair the pipe with minimal downtime but so far had not yet been able to come up with a method for how they would do this.

1. Severe leak
2. Leak plugged with Belzona 1291
3. Attention to detail during application of Belzona 1161
4. Finished application

Application was carried out in accordance to Belzona Know-How System Leaflet VPF-11. Temporary seal effected with Belzona® 1291 before reinforcing with Belzona 1161 to create more permanent seal.

To shut down the pipe line for a traditional repair could cost the company up to £60,000 per hour. Belzona were able to offer a very cost effective live leak repair. The repair, visited 3 years on was showing no sign of deterioration.
