# BELZONA REPAIR TO PUMP SHAFT BEARING SURFACE

ID: 2692

Main cooling water pump at Power Station. The back up pump was the only pump supplying cooling water to the Power Station meaning the reserve pump had to be fixed immediately.

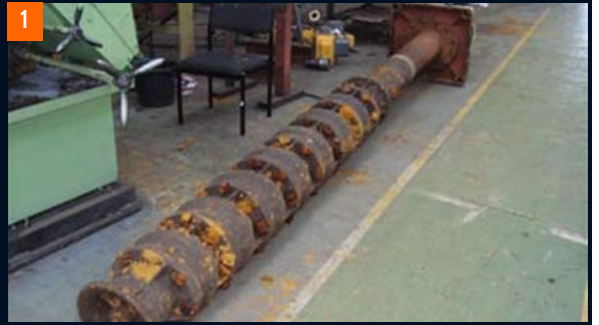
Pump waiting to be dismantled  
Damaged area on shaft clearly visible  
First machine cut being applied to  
Belzona 1131 rebuild Completed repair  
ready for pump re-assembly

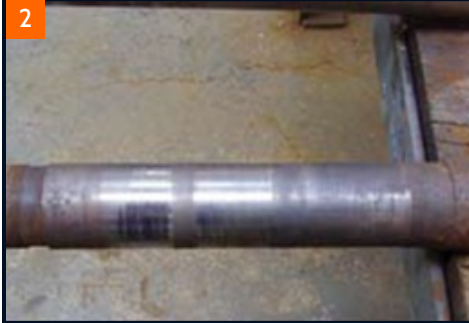
Damage had occurred to the drive shaft of the pump. Previously repaired using hot metal spraying which caused 'pick up', the customer required a fast repair.
