# BELZONA REPAIRS SUBWAY HANDRAIL

ID: 27

Handrail of escalator at a subway station

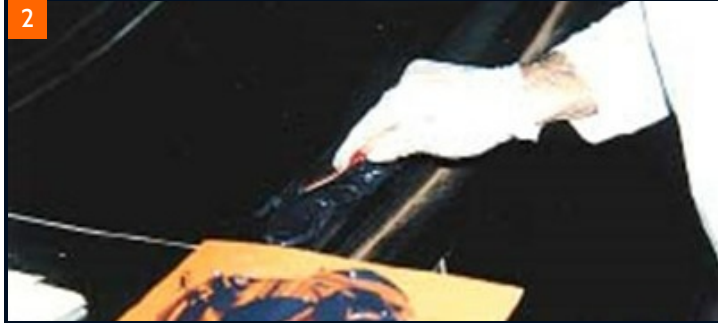
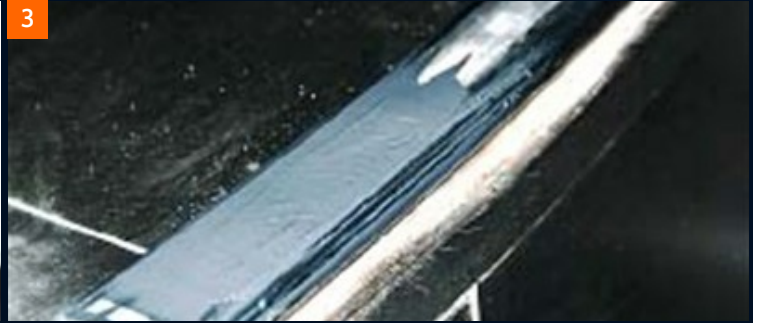
Due to vandalism, a chunk of rubber was missing from the handrail.

1. The damage due to the vandalism
2. Application of Belzona 2311 (SR-Elastomer) in progress
3. The finished repair ready for operation

The application was carried out in accordance with a modified version of Belzona Know-How Leaflet SHM-1.

The repair was completed with \$50.00 of Belzona product. The alternative was hot vulcanizing which would have shut the escalator down for one day and cost approximately \$2,000. The repair took only two hours to perform, and after three years, is still in operation today.
