# BELZONA REPAIRS AND PROTECTS SULFURPRILL TOWER

Prill tower for pelletizing sulfur.

Oil refinery in Saudi Arabia

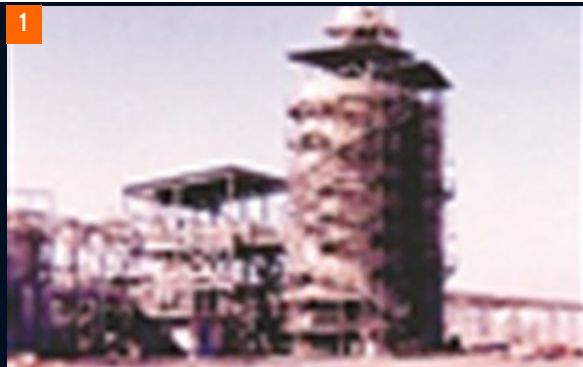
1. General view of the tower
2. Cracks and damaged concrete required extensive repairs with Belzona 4111
3. Steel/concrete joint sealed
4. Application of Belzona 5811 underway

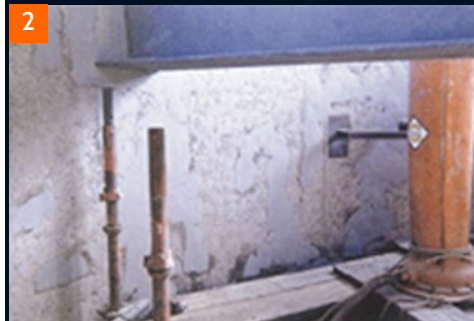
Acidic content of moist sulfur had led to severe attack of the concrete.

Belzona Systems allowed the tower to be repaired and protected quickly and effectively ensuring many years of continued service. The stainless steel cone in the base of the tower was not coated, but the Belzona provides an excellent seal at the steel/concrete interface. Belzona Systems were also used on the external surfaces to provide additional protection from the marine atmosphere.
