# BELZONA PROTECTS LARGE COOLING WATER PUMP

ID: 271

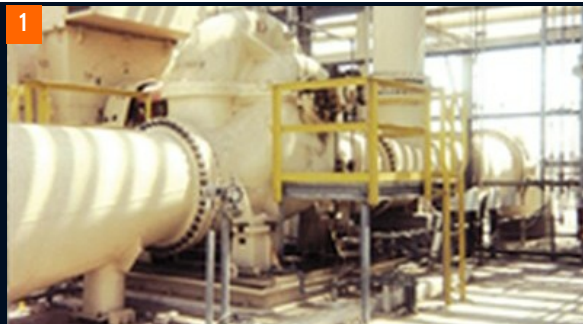
1. General view of the pump installation
2. The size of pump is clearly evident
3. Rebuilding work underway
4. Completed application

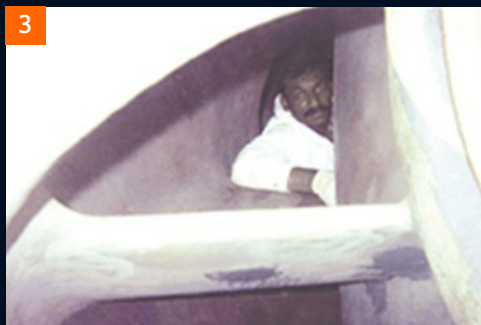
Cavitation and general erosion-corrosion damage had reduced the pumps efficiency to unacceptable levels. The plant has a limited power supply and was looking for all ways to reduce demand.

The application was carried out in accordance with Belzona Know-How System Leaflets CEP-2, CEP-3, CEP-5, and CEP-10.

Belzona 1111 (Super Metal)
