# BELZONA PROTECTS HOT PIPEWORK

ID: 2710

Hot pipework (aprox. 110°C) in the refinery

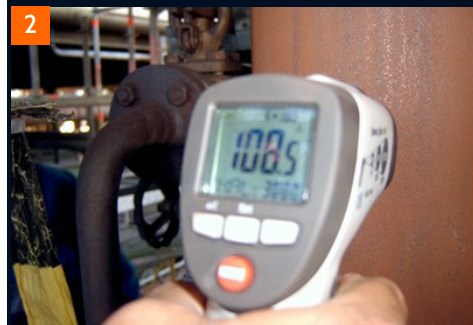
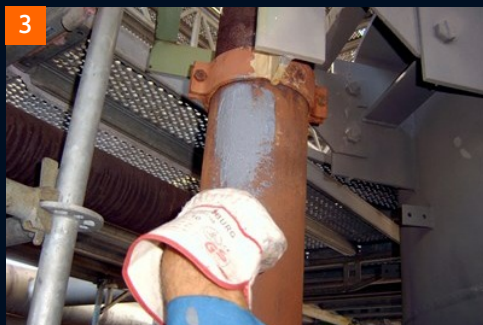
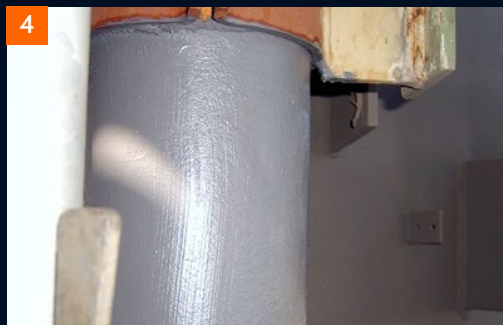
Original paint system was failing allowing pipework to corrode. New protection required to be applied whilst system remained operational.

1. Surface preparation underway
2. Temperature reading of the hot pipe
3. Application of coating
4. Finished application

Application was carried out in accordance with Belzona System Leaflet TCC-5. As the pipe was in hot service only minimal surface preparation could be carried out to remove the existing coating. Once the pipe was returned to a sound substrate, the product was applied by brush to the hot pipework.
