# BELZONA SEALS LEAKING FLANGE

ID: 2713

Large flange in hot brine process system

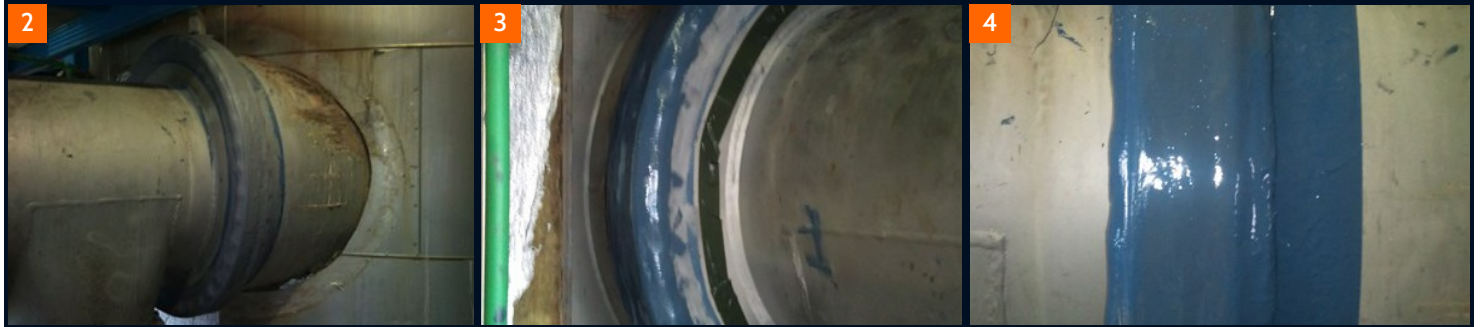
Flanged joint was leaking at the gasket and through the bolts. Customer required an in-situ repair to seal the leak as joint could not be dismantled to effect a conventional repair.

1. Leaking flange
2. Belzona 1111 applied to bolts
3. First coat of Belzona 1391 applied
4. Completed application

Application was carried out using a modified version of Belzona Know-How System Leaflet VPF-11. The surface was prepared by grit blasting. The bolts were fully encapsulated using Belzona® 1111 to seal the leaks in these areas. Following this Belzona® 1391 incorporating Reinforcement tape was used to completely encapsulate the flange joint.
