# BELZONA PROVES TO BE THE MATERIAL FOR CHEMICAL CONTAINMENT AREAS

ID: 272

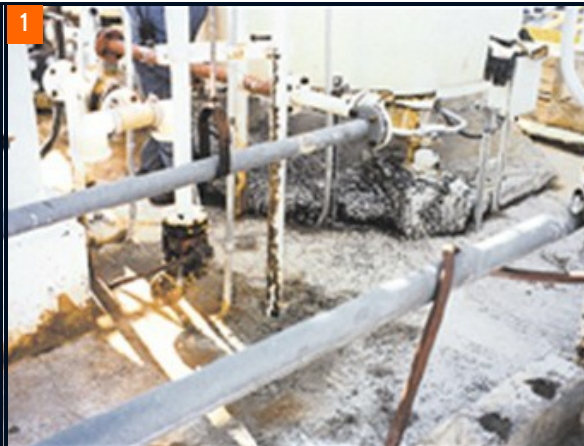
Repetitive exposure to concentrated hydrochloric and hydrofluoric acids, which eroded the concrete substrate.

1. The area has been cleaned/degreased  
Belzona 4131 is being used to rebuild the eroded areas
2. Belzona 4911 has been applied prior to the final coating
3. The completed application.

At least five imitation products had failed to protect the containment area prior to Belzona. Belzona® 4131 was used to rebuild the eroded areas, and Belzona® 4311 was used to coat the entire containment area.
