# BELZONA SEALS SULFUR HEXAFLUORIDE LEAKS

ID: 273

Flange joints on electrical switch-gear where Sulphur Hexafluoride (SF<sub>6</sub>) is used as a gaseous insulant.

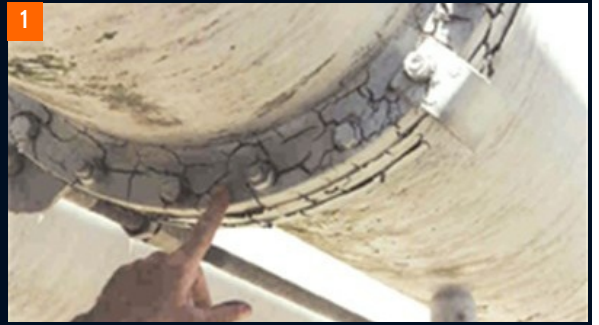
Leakage at flange joints due to breakdown of the original mastic sealer. There was also a breakdown of the original paint system on the equipment.

1. Existing joints showing failed paint system
2. Belzona 1111 applied to seal joint
3. Area primed with Belzona 3921
4. Spray application of paint system to complete the application
