# BELZONA RETURNS THIS 20-YEAR-OLD PUMP TO LIKE NEW CONDITION

ID: 274

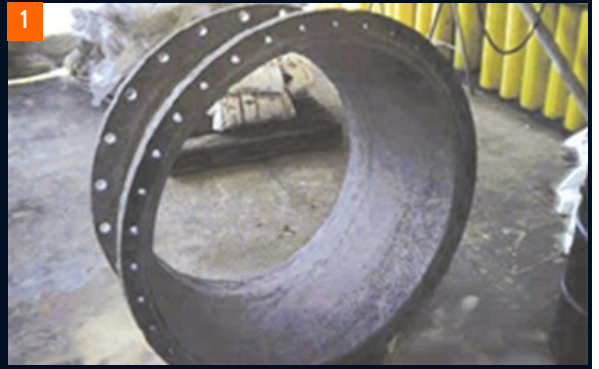
The pump was heavily scaled and had significant corrosion.

1. The pump diffuser connecting piece prior to the application
2. Blasted with Belzona 1111 applied
3. The pump piece has been coated with Belzona 1341

The pump was grit blasted and cleaned. Belzona® 1341 was applied to the pump volute, impeller and the inside surfaces of the flow diffuser. Belzona® 5811 was applied to the outside of the volute, the diffuser and the connecting pieces after which Belzona® 1111 was used to rebuild the worn areas on the diffuser and connecting pieces.
