# BELZONA PROTECTS FLARE DRUM

ID: 2740

Flare knock-out drum

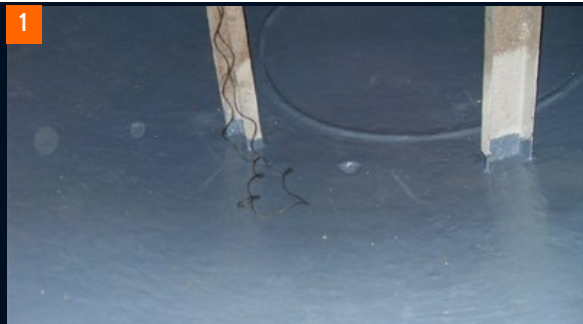
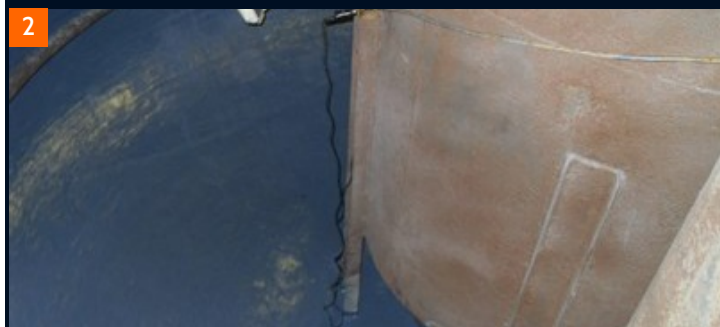
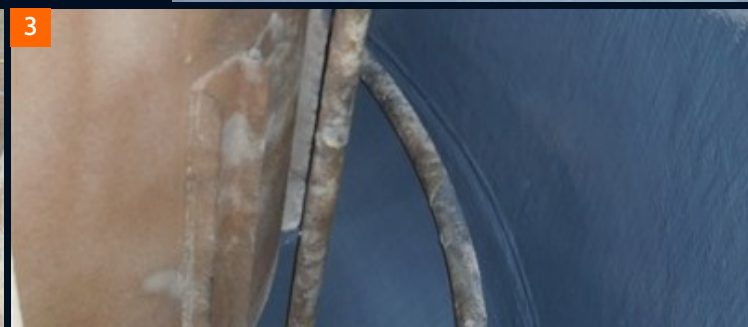
Vessel suffering internal corrosion. Coating required to extend service life of the vessel.

1, 2 & 3. various views of the Belzona 1391 applied to the vessel interior.

Application was carried out in accordance with Belzona Know-How System Leaflet TCC-5.

Belzona® 1391 provides excellent corrosion protection at elevated temperatures. In particular the coating is capable of withstanding the extreme variations in temperature and pressure the vessel is exposed to. The ambient temperature curing coating lends itself to application on-site.
