# BELZONA THWARTS BLOWER FAN CORROSION

ID: 275

52" diameter blower fan

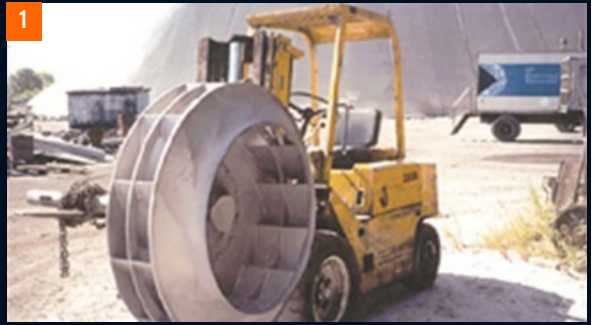
The high moisture environment the fan was operating in led to corrosion. In addition, by-product was accumulating on the surface, putting the fan out of balance.

1. The fan prior to the application
2. Fan undergoing surface preparation by grit blasting
3. The surface preparation has been completed
4. The fan has been coated with Belzona 1341 and is ready to be put back into service
