# BELZONA RESTORES LOCAL BANK

ID: 2776

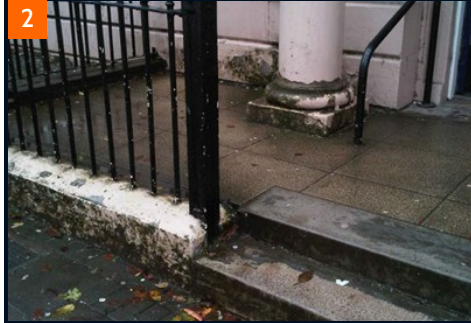
Age and the effect of weather had caused serious deterioration to the buildings facade.

1. Fascia of the building prior to application
2. Damaged Column
3. General view of the completed application
4. The refurbished bank entrance

Application was carried out in accordance with Belzona Know-How System Leaflets WPA-1 and WPA-4. The defective external wall coatings were removed. Some of the broken profiles around the windows and the lintel above the front door were repaired with Belzona® 4141. Belzona® 5151 was then applied to the stonework to protect the surface from further damage.
