# BELZONA RESTORES SAFETY TO FIRE ESCAPE STAIRWAY

ID: 2777

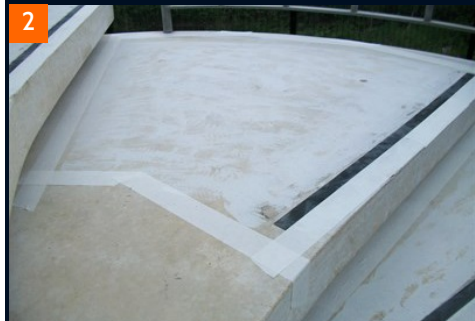
The concrete steps had worn and the current safety grip system had become almost non-existent due to heavy foot traffic and weathering. A member of staff had slipped down the steps and injured themselves so solution to this serious slip hazard required.

1. Staircase prior to application
2. Surface prepared ready of application
3. Completed Application
4. Completed Application

The application was carried out in accordance with Belzona Know-How System Leaflet FPA-8. Belzona® 4411 in grey was applied to the steps with Belzona® 9221 (Surefoot White Aggregate) incorporated into the main step areas and Belzona 9231 (Surefoot Aggregate) incorporated into the coating on the nosings.
