# FLANGE SEALING WITH BELZONA

ID: 2785

Large leaking flange

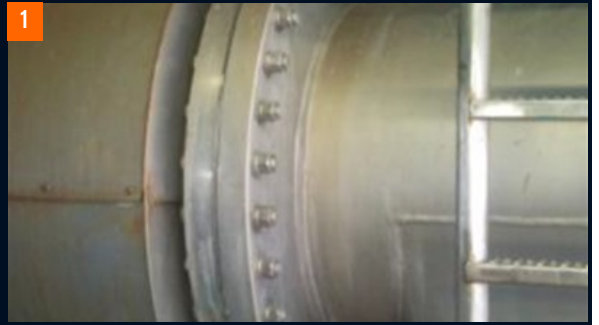
The leaking flange had to be sealed without dismantling as production could not be interrupted.

1. Leaking flange
2. Application of first coat
3. Application of second coat
4. Complete application

Application was carried out in accordance with an adapted version of Belzona Know-How System Leaflet VPF-11. After grit blasting, the nuts and bolts were encapsulated with Belzona® 1111 before Belzona® 1391 was applied by brush, incorporating Reinforcement Tape, to completely seal the circumference of the flange joint.

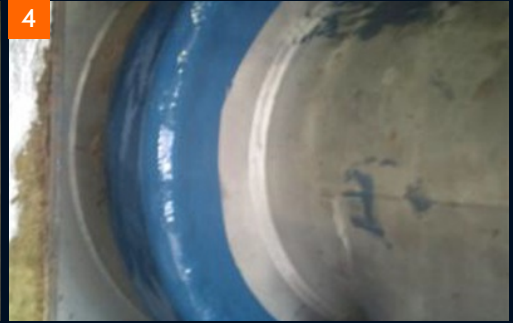
The application was completed in two days and has created a heat resistant seal without having to dismantle the flange. This ensured minimal disruption to production.
