# BELZONA REPAIR ON STEEL MILL

ID: 2786

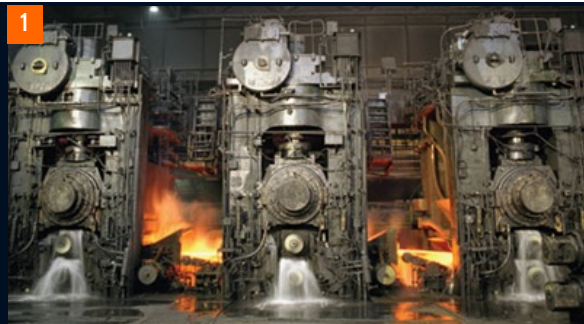
In the rolling mill housing there were several wear plates which guide the hot steel slabs. Impact and vibration from the heavy metal slabs create damage to the housing behind the wear plates. A significant gap occurred between the support and plates leading to misalignment.

1. Mill Housings
2. Applying Release Agent to underside of wear plates
3. Injection Holes
4. Finishing off the injection of Belzona 1321
