# BELZONA SEALS LEAKS ON SUPERGRID TRANSFORMER

ID: 2787

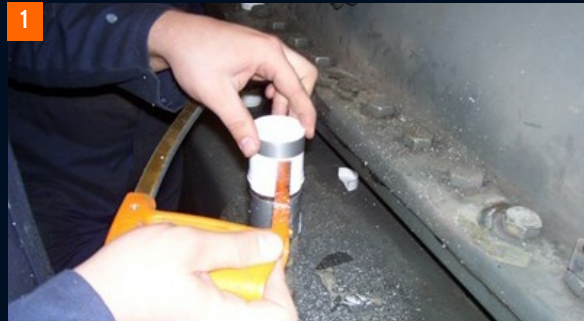
1. PVC pipe being cut into sections to cover bolts
2. Surface preparation using MBX Bristle Blaster
3. The Belzona 1161 encapsulated bolts
4. Completed application with Belzona 5831 applied

Application was carried out using a modified version of Belzona Know-How System Leaflet VPF-11a. after preparing the metal with an MBX Bristle Blaster, Belzona® 1161 was then used to seal the bolts using PVC pipe of a wider diameter placed over the bolts and filled with the Belzona until totally encapsulated. Once cured, The PVC cups were cut away so that the entire flange could then be covered with Belzona® 5831 to provide overall corrosion protection.
