# BELZONA RESTORES BEARING HOUSING TO LIKE-NEW CONDITION

ID: 280

A bearing housing from the winder section of a paper machine used to support and provide tension to the reels of paper.

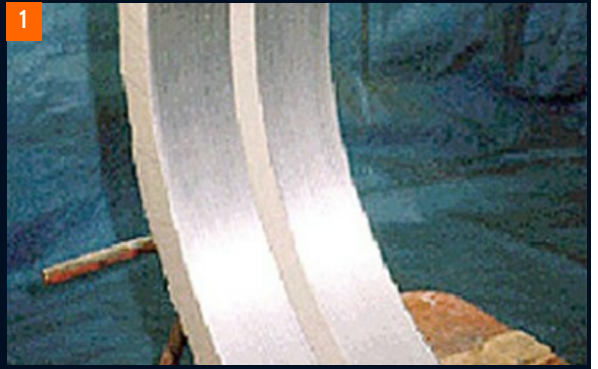
This winder bearing housing suffered mechanical damage from vibration, foreign substances and irregular rotational motion.

1. Surface preparation of bearing housing
2. View of damaged flange mounting
3. The bearing housing is ready for service

The application was carried out in accordance with Belzona Know-How System Leaflet MPT-6. Applied by hand and machined to tolerances.

Belzona® 1111 (Super Metal) was machined to form a perfect cylindrical bearing surface while maintaining the lubrication seal. The flange mounting was also rebuilt and machined for a secure mating surface to the paper machine framework. The winder section of the paper machine must run continuously and reliably in order for the mill to remain profitable.
