# BELZONA EXTENDS THE LIFE OF THIS TRUNION END BEARING

ID: 281

Trunion end bearing for a 40-ton lime kiln.

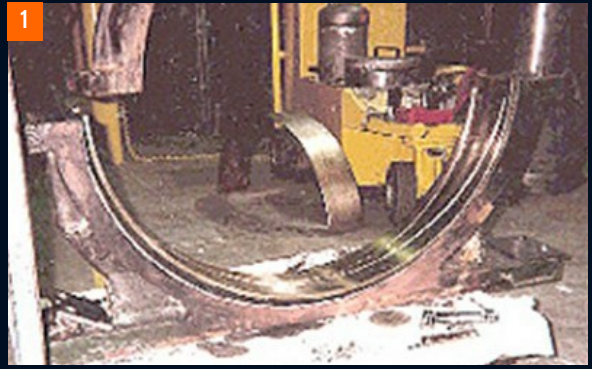
The lubrication system failed on the trunion end bearing on a 4-ton lime kiln, wearing through the entire bronze liner and into the cast iron pillow block.

1. Pillow block damage evident
2. Trial fit of new bronze liner
3. Rebuilt cast iron using a forming technique
