# IN-SITU BELZONA SHAFT REPAIR

ID: 2811

Air handler shaft

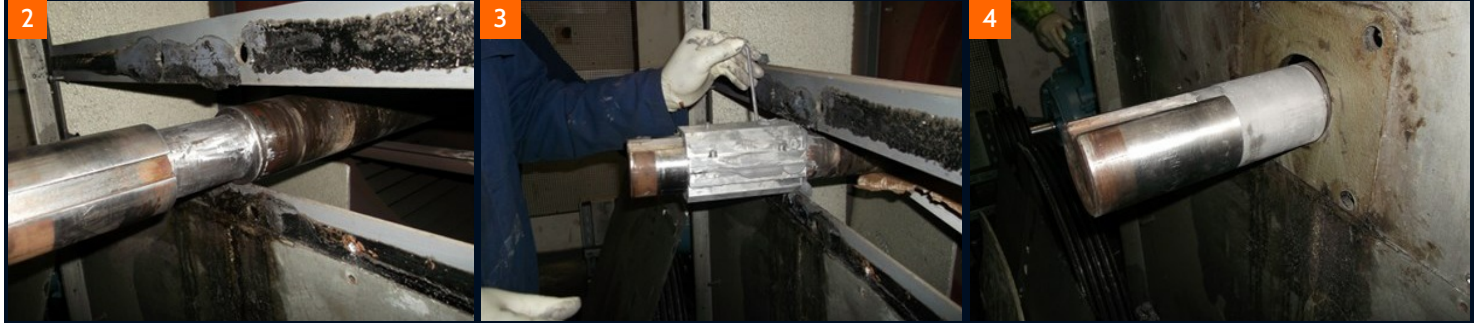
## PHOTOS

The worn shaft was causing vibration and so much noise that they could not use the lecture hall.

1. Worn shaft
2. Prepared surface
3. Former being clamped in place
4. Completed repair

The repair was carried out in accordance with the Belzona Know-How System Leaflet MPT-2. The required shaft diameter was restored using a pre-fabricated former.
