# BELZONA EXTENDS SERVICE LIFE OF THIS VERTICAL PIVOT BEARING HOUSING

ID: 282

Vertical pivot bearing housing on a piece of heavy equipment.

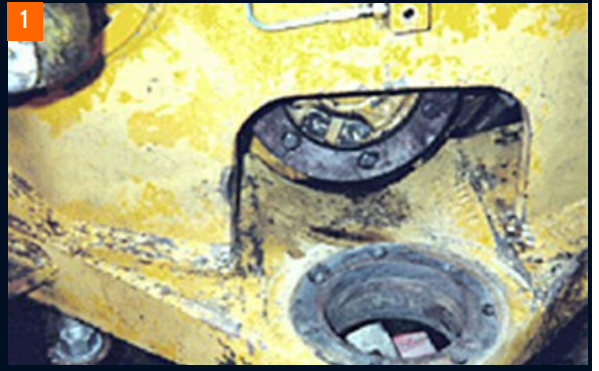
Ordinary wear and tear eventually enlarges the housing and causes play in the body pivot pin during use.

Damage evident around pin Application in progress New bushing aligned and installed
