# BELZONA LOW ODOUR SOLUTION FOR TRAINING COLLEGE ROOF

ID: 2825

Roof over Police Training College.

Police Training College, South East England

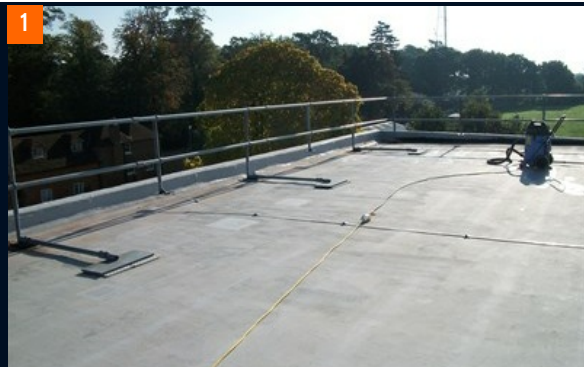
1. The roof being washed down ready for the repairs and coating
2. Preparation completed and the Conditioner being applied
3. First and second coats of Belzona 3111 completed
4. Completed application of Belzona 3111 system

Application was carried out in accordance with Belzona Know-How System Leaflet RPA-8. Damage in the asphalt was repaired with Belzona® 4111 before the complete roof was sealed with a fully reinforced Belzona® 3111 System.
