# BELZONA SIMPLIFIES CONVEYOR BELT REPAIRS

ID: 2827

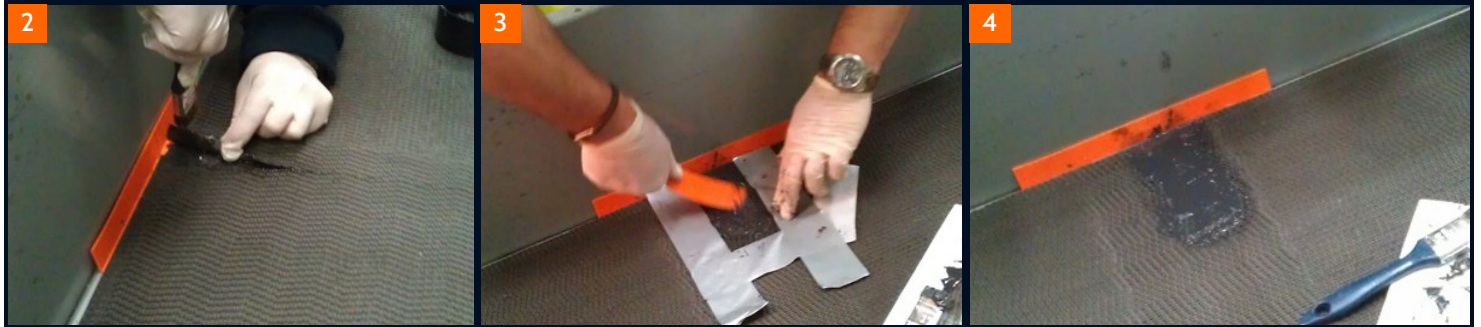
From time to time the conveyor belt will get damaged from the papers or magazines getting jammed up between the side walls and the rollers.

1. Roughing up the damaged surface
2. Applying the Belzona Elastomer Conditioner
3. Application of Belzona 2311 to the masked area
4. Completed application with Belzona Reinforcement tape embedded in the repair and ready to go back in service

Application was carried out in accordance with Belzona Know-How System Leaflet SHM-1. The conveyor belt was stopped once the shift had finished and can be repaired before the next start-up.
