# BELZONA CORRECTS OVERSIZED KEYWAY

ID: 283

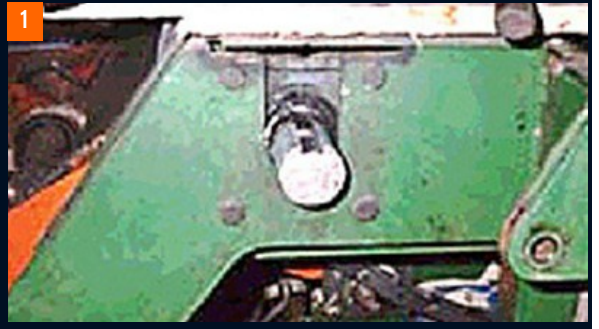
This lumber decker keyway takes a tremendous beating because of cyclic loading. Because of the start-stop characteristics, the keyway housing became oversized.

1. The equipment prior to the application
2. The keyway has been repaired
3. The material has cured and the equipment is ready for service

The application was carried out in accordance with Belzona Know-How System Leaflet MPT-4. This repair was done in place without disassembly using a Belzona forming technique.
