# EXTENDED DOWN TIME AVERTED BY USING BELZONA

ID: 286

Shaft spline used as the main transmission of power to the mandril mill.

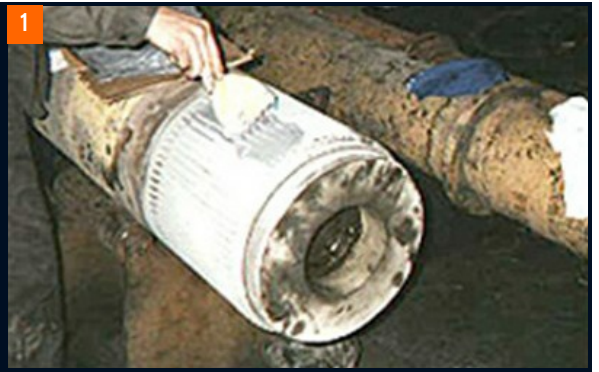
1. Application of Belzona 1121 to spline
2. Liberal amounts of Belzona 1121 to spline
3. The gear is being fitted onto the spline
4. Final location of gear alignment

The application was carried out in accordance with Belzona Know-How System Leaflet MPT-5. Belzona® 9411 (Release Agent) was applied to the gear, and Belzona® 1121 (Super XL-Metal) was liberally applied to the spline and gear before mating.
