# BELZONA MAINTAINS CHIPPER DISC POCKET PROFILE

ID: 287

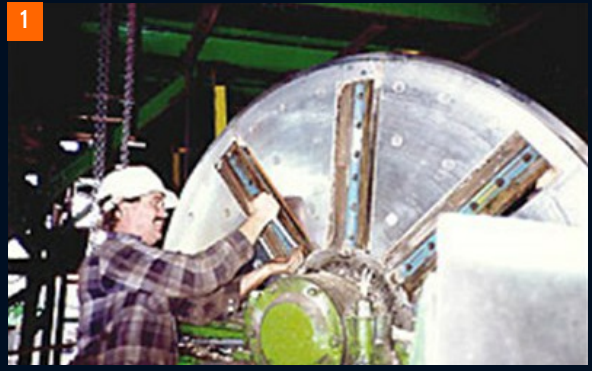
1. Knife removal from the disc
2. Damage to the pocket profile
3. Applying Belzona 1811 (Ceramic Carbide)

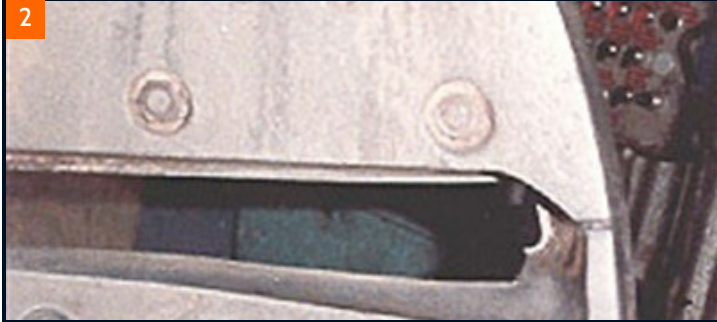
The chipper disc pockets exhibit wear and require constant maintenance. Off-size chips adversely affect the pulping process and the quality of the resultant paper.

Deterioration of vertical flywheel-type chipper disc pocket profile.

The pockets are repaired in 1/2 day without introducing heat stresses to the metal substrate. Before attempting the repair, all discs should be evaluated for structural integrity. With the aid of a dying compound, engineers will be able to determine the extent of stresses within the metallic substrate.
