# BELZONA EXTENDS THE LIFE OF THIS SCREW PRESS

ID: 288

Shaft wall thickness of an Andritz Screw Press.

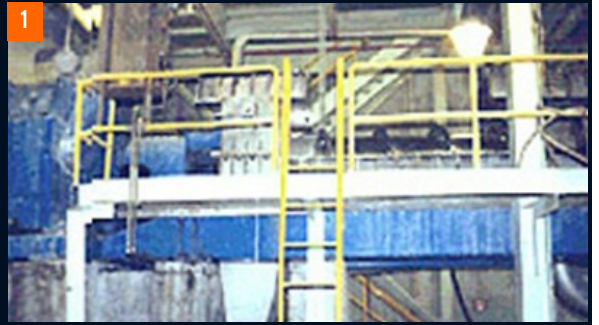
The Andritz Screw Press is used to remove water and thicken the pulp stock. The screw shaft on this machine lost nearly half of its 7/8" wall thickness due to abrasion from the fiber as it is pressed against the screw.

1. Overall view of the Andritz screw press
2. Surface preparation by grit blasting
3. Finished application
4. After 6 months of operation
